Manhole Inspection Summary

Manhole # S19W__017MH

Insp Date: **6/27/08 1:37 PM**

Location Address: **1703 sexton st**

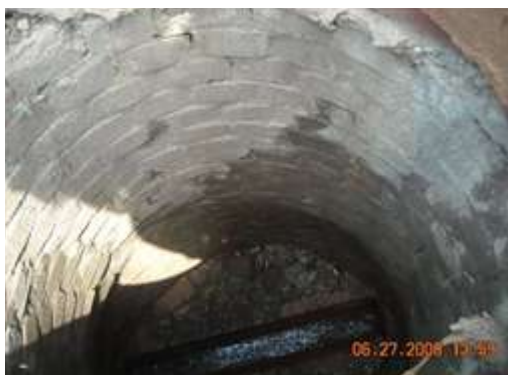
Defect 4

Corbel Material: **Brick** ☐ Parged Type: **Concentric/Eccentric**
Condition: ☒ Sound ☐ Cracked ☐ Root Intrusion ☐ Loose Brick ☐ Deteriorated
Infiltration: ☐ None ☐ Joint ☐ Cracks ☐ Mortar ☐ Roots ☒ **Wall**

corbel flow wall

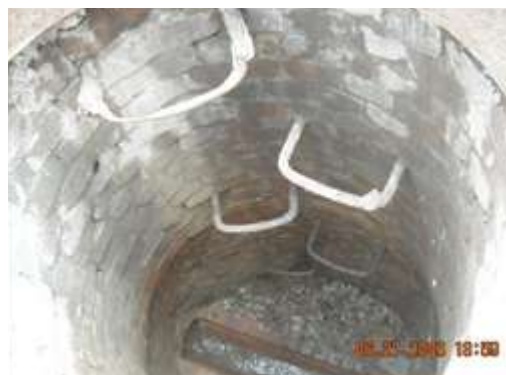
Defect 3

Steps Count: **5** Missing: **0** ☒ **Corroded**

corroded steps

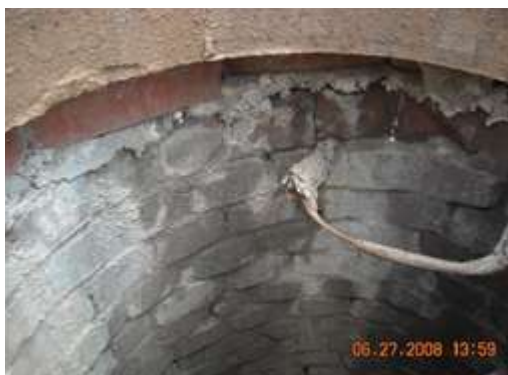
Defect 2

Chimney / Frame Adjustment ☒ Exists Material: **Brick and Concrete** ☐ Parged Height: **2** (in.)
Condition: ☐ Sound ☐ Cracked ☐ Root Intrusion ☒ **Loose Brick** ☒ **Deteriorated**
Infiltration: ☐ None ☒ **Joint** ☐ Cracks ☐ Mortar ☐ Roots ☒ **Wall**

Deteriorating Chimney

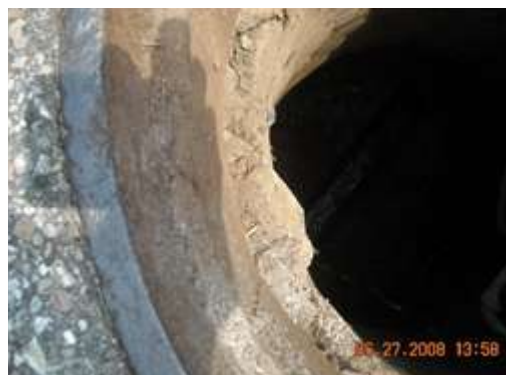
Defect 1

Frame Offset: **1.5** (in.) Condition: ☒ Sound ☐ Cracked ☐ Leaks

frame offset

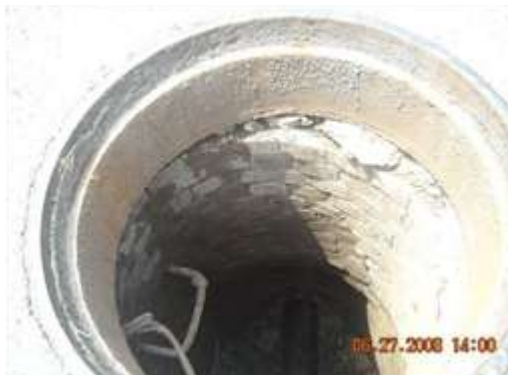
Defect 7

chimney flow wall

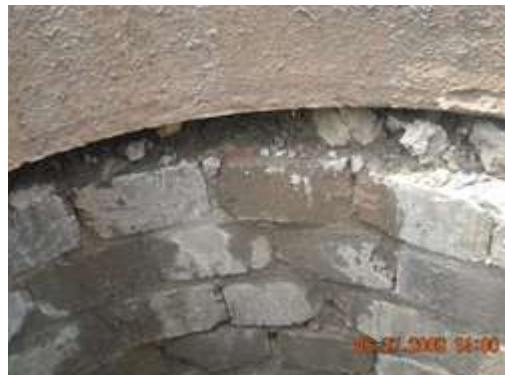
Defect 6

loose bricks in chimney

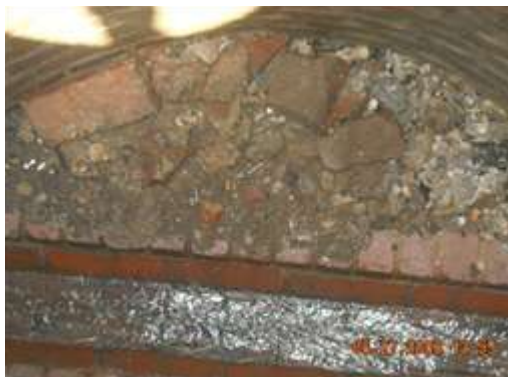
Defect 5

Bench ☒ Exists Material: **Brick** ☐ Parged
Condition: ☐ Sound ☐ Cracked ☐ Root Intrusion ☐ Deteriorated ☐ Leaks ☒ **Debris**

bench cond debris

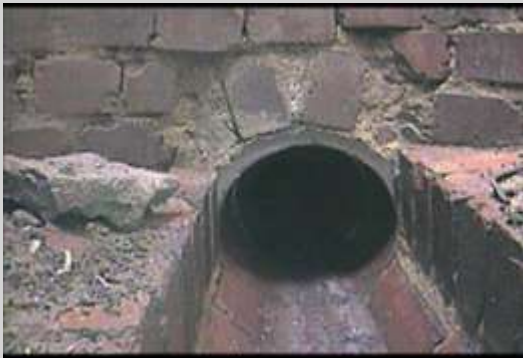
12 O'Clock Outflow

8 in. Circular Gravity Sewer
Pipe Out @ 12 O'Clock

Pipe Height: **8.4** (in.) Rod and Bar (Angled)
Pipe Material: **Clay** ☐ Pipe Lined
Invert Depth: **8.16** (ft.) Flow Characteristics: **Slow**
Deposits: ☒ None ☐ Mud ☐ Sludge ☐ Debris ☐ Grease
Silt Depth: **0** (in.) Deposits Extent:
Infiltration: **None** Pipe Seal Cond: **Sound**

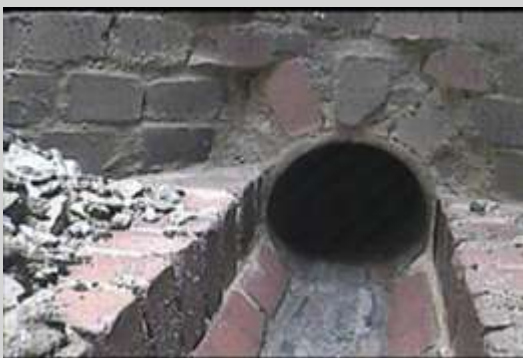
6 O'Clock Inflow

8 in. Circular Gravity Sewer
Pipe In @ 6 O'Clock

Pipe Height: **8.4** (in.) Rod and Bar (Angled)
Pipe Material: **Clay** ☐ Pipe Lined
Invert Depth: **8.15** (ft.) Flow Characteristics: **Slow**
Deposits: ☒ None ☐ Mud ☐ Sludge ☐ Debris ☐ Grease
Silt Depth: **0** (in.) Deposits Extent:
Infiltration: **None** Pipe Seal Cond: **Sound**
